Structural Investigation into the Causes of Cracks in Building and Solutions: A Case Study

The study of causes and solutions to cracks was considered in the study using a case study of a two-storey office building in the University of Ibadan, which has different categories of cracks and it is making the use of the building uncomfortable by the occupants. Appropriate remedial measures will be proposed to save the building from further deterioration and to extend the life of the structure.

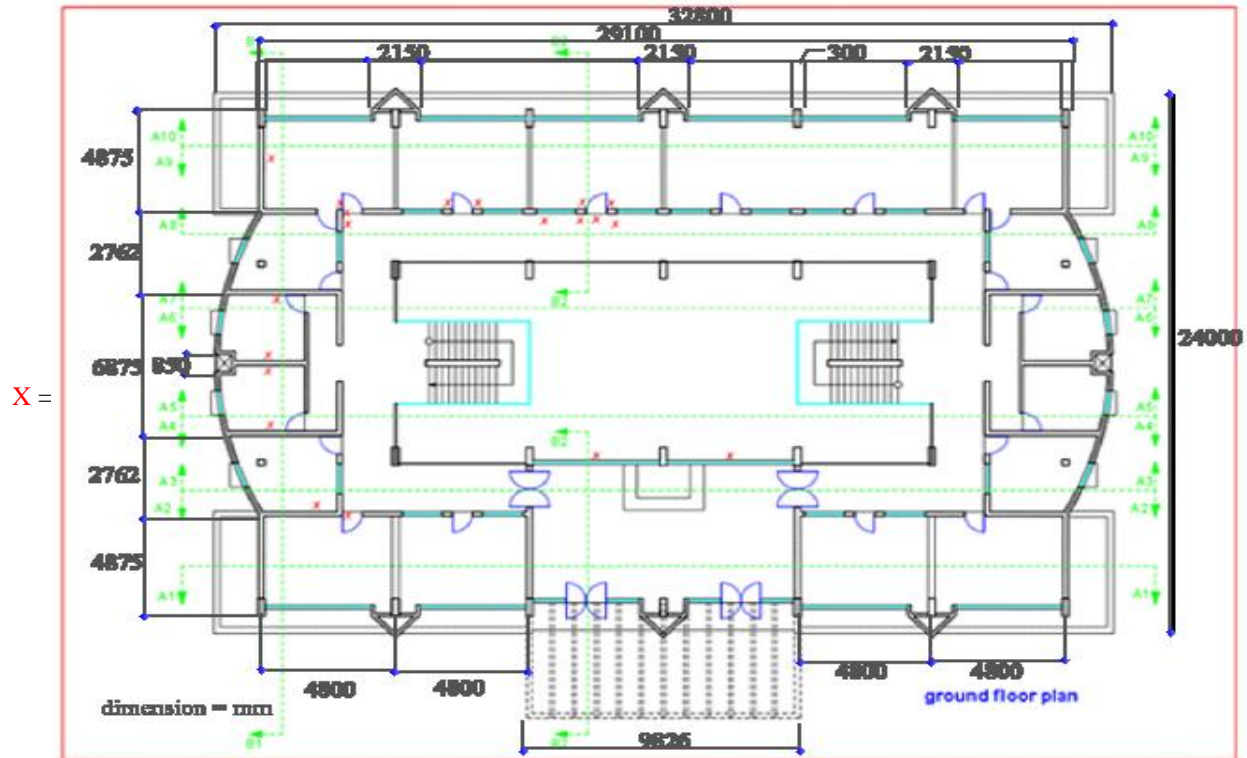
Fig.1. Ground floor plan of the building

X = Location of the cracks

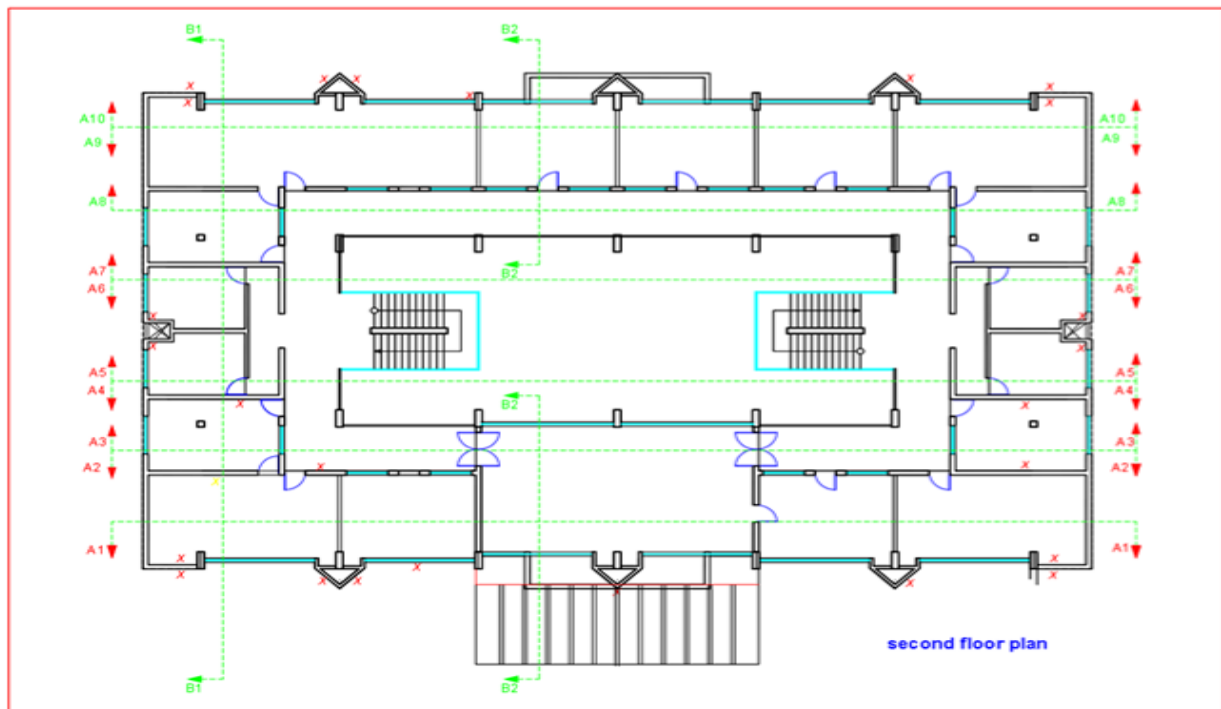
Fig.2. Second floor plan of the building

X = Location of the cracks

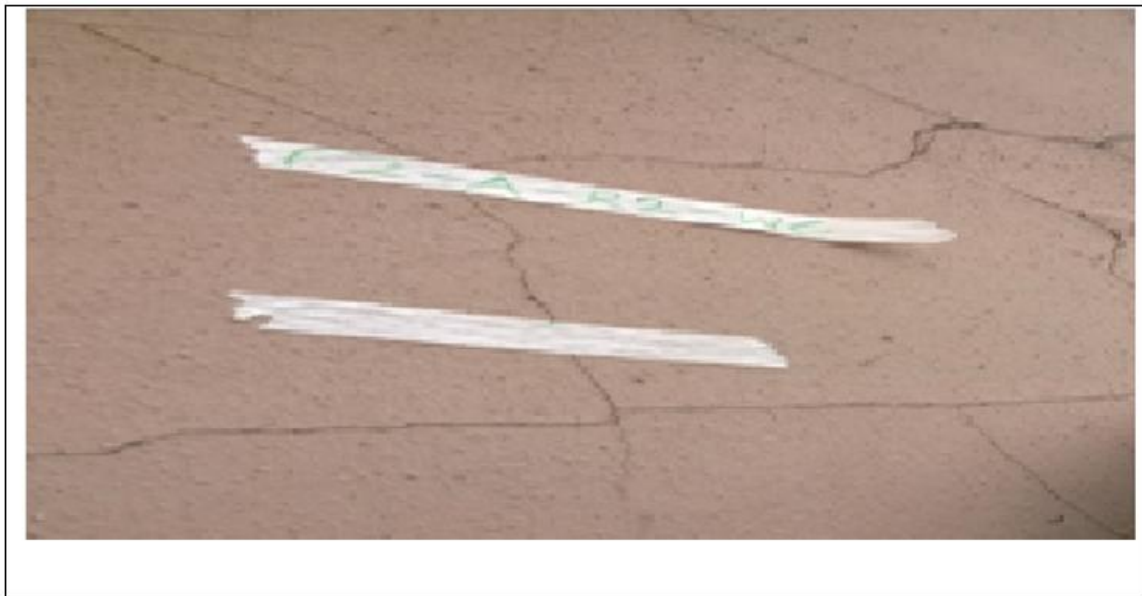
The parts of the building caused by drying shrinkage are: F0-A-R4-W4, F1-A-R4-W1, F2-A-R2-W6. The cracks were caused by shrinkage of the plastering, since it is a surface crack; the shrinkage may be due to use of high ratio of cement to sand, and inadequate curing. Shrinkage crack occurs during the first dry spell after plastering. Their measured values were shown in Tables 2 and 3, and picture in Plate 2. The proffered solution is that, this type of crack could be left unattended up to the normal time for renewal of finishing coat when this will get filled up, or the surface is scrap and refill with good mix ratio of cement and sand and proper curing.

Plate 2. Picture of random cracks due to drying shrinkage

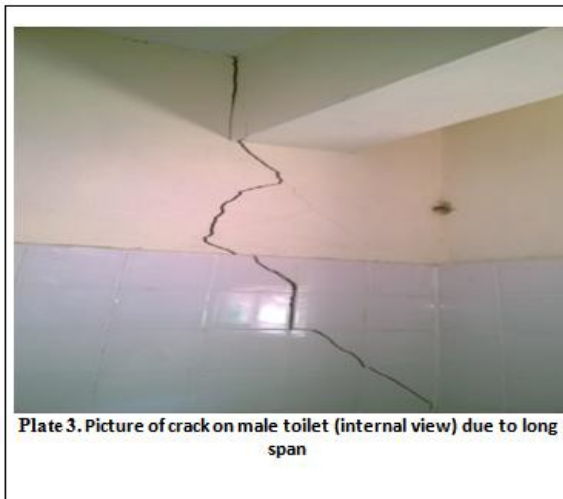
The second type of cracks observed (F0-Female Toilet-W1, F0-Male Toilet-W1, F1-Male Toilet-W2, F1-Male Toilet-W3, F0-A-R4-W4) were primarily on the sandcrete wall under a 7.3m span flanged beam. The cracks on F0-Female Toilet-W1, F0-Male Toilet-W1, F1-Male Toilet-W2, and F1-Male Toilet-W3 were similar in their cause. It was observed that the long spanned beam (7,226mm=7.3m), rested on the non-load bearing wall for support due to sagging at the mid-span thus subjecting the wall to stresses that it was not designed to sustain (See Tables 2 and 3, and Plate 3). The sagging effect of the beam may be as a result of faulty design or inadequate reinforcement provided during construction. The suggested solution is to introduce a column (preferably a steel section) to support the beam along the mid span while the cracked wall should be removed and replaced with load bearing wall. In addition, two columns should be erected from the basement to support the slab at the lobby of the toilet entrance.

Plate 3. Picture of crack on male toilet (internal view) due to long span

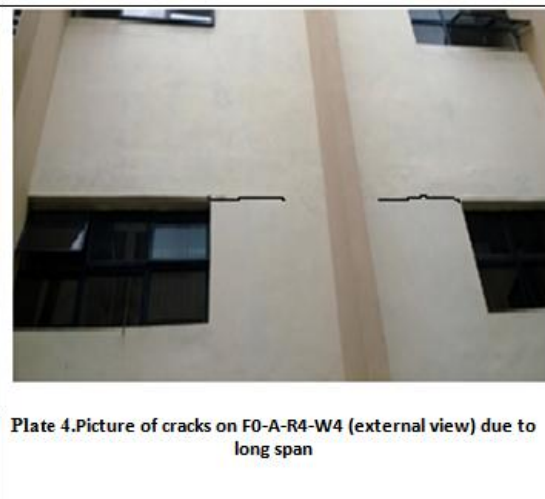
Plate 4. Picture of cracks on F0-A-R4-W4 (external view) due to long span

The type of crack shown in Plate 4 occurred at wall F0-A-R4-W4 (External View). This type of crack generally occurs when windows and room spans are very large. The horizontal cracks at the window lintel level (See Table 2 and Plate 4) are due to pressure exerted on the wall by slab, because of drying shrinkage and thermal contraction. This pressure resulted in bending of the wall, which caused cracking at a weak section, that is, at the lintel level of the window openings. These cracks could have been avoided if slip joint at beam supports on the walls have been provided, to permit movement without encountering much restraint. The cracks can be repaired by filling with a mastic compound after widening and cleaning the cracks. These cracks if repaired with strong mortar have a tendency to occur again [12, 29].

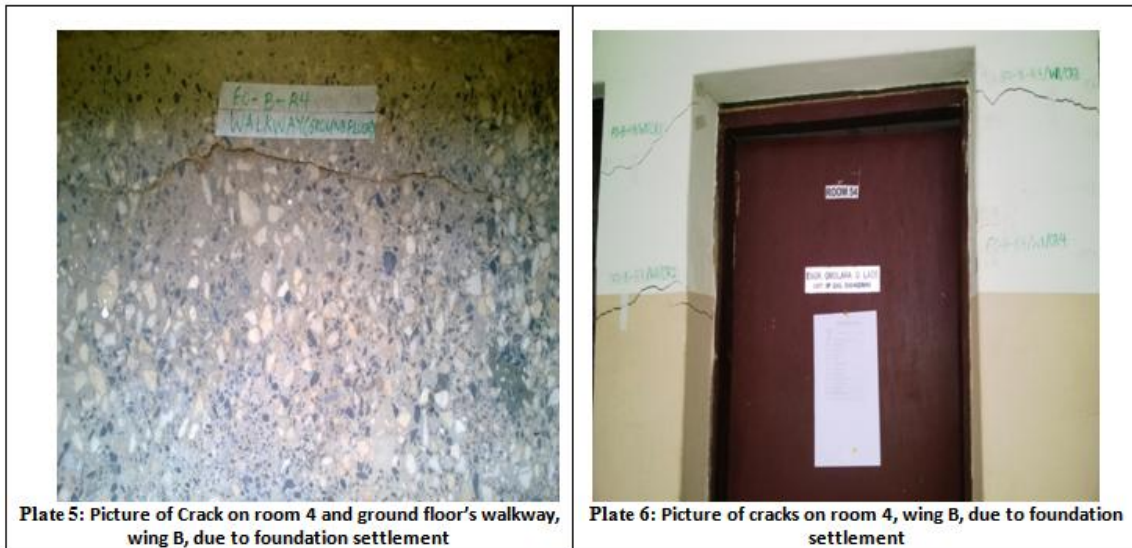
The third type of cracks observed at F0-B-R4-W1-CR1, F0-B-R4-W1-CR2, F0-B-R4-W1-CR3, F0-B-R4-W1-CR4, Door Frame, Ground floor Walkway were caused by foundation settlement (See Table 2, Plate 5 and 6).

It was discovered through topographical survey, that lack of drainage at the open courtyard allows percolation of water into the soil and thus this crack undermines the sand under the floor and including the wall strip footing. This could be said to be responsible for the cracks in the region, for the cracks occurred due to settlement of soil at the region of the courtyard. The settlement also caused crack along the wooden frames of the door, which distorted the frame making it difficult to close and open the door. For Ground Floor Walkway, the crack was caused by poor drainage of water due to heavy runoff getting into the foundation at this region. The terrazzo floor settled under human traffic load (live load) and cracked across the corridor to the adjacent room. Such a settlement generally not being uniform in different parts resulted in cracking of the ground floor walkway. The provision of appropriate drainage and reconstruction of the wall footing and the floor in the affected area will eradicate the cracks and prevent future ones. Cracking due to shrinkage of wood can be concealed with the help of architraves and will not present much of a problem [29]. For cracking due to slack between holdfasts, the only satisfactory remedy is to dismantle the masonry so as to remove the frame and to reattach with seasoned frame after securely fastening the holdfasts to the frame.

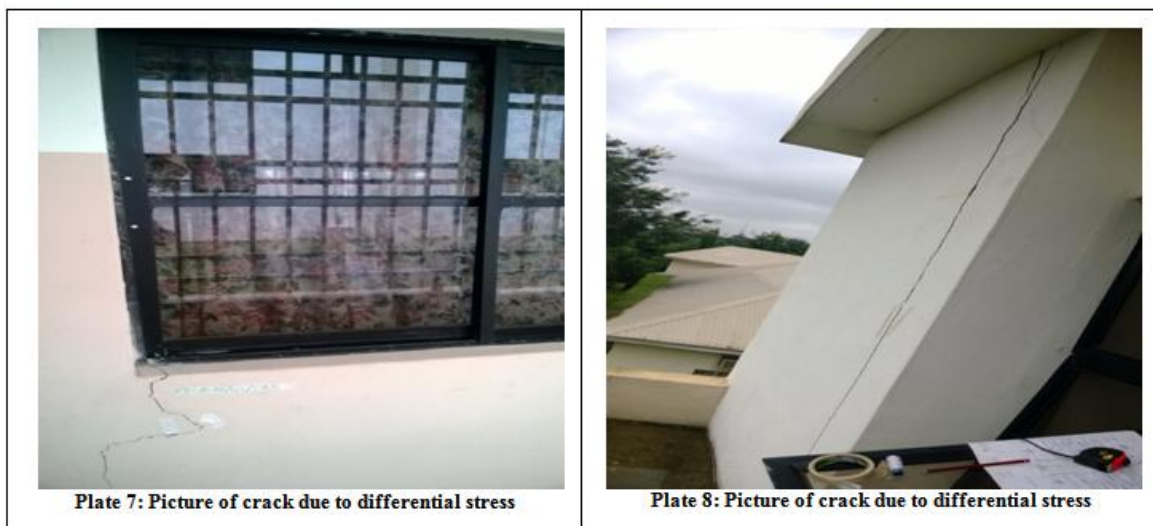
The fourth type of observed cracks at F0-B-R4-W1-CR5 (External View), F2-A-R2-W3 (Internal and External view), F2-A-R6-W3 (Internal and External view), F2-B-R2-W3, F2-B-R7-W3. (Internal and External view) was caused by movement due to creep. The crack on F0-B-R4-W1-CR5 (External View) is a diagonal crack (See Tables 2 and 3, Plate 7), which occurred as a result of differential stress and strain between different regions of the wall. It can be seen that portions of wall beside the window act as pillars and are stressed much

more than the portions below the window. Thus, as a result of differential stress, vertical shear cracks occurred in the wall. To minimize these cracks, too much disparity in stress in different walls or parts of a wall should be avoided. If RC slabs, RC lintels over openings and masonry in plinth and foundation have good shear resistance, cracking in question would not be very significant. The proffered solution for crack on F0-B-R4-W1-CR5 can be sealed up with mortar mix ratio of 1 Cement: 1 lime : 6 Sand in the dry season or 1 Cement:2 Lime:9 Sand in the rainy season, with the avoidance of sharp sand for plastering it, and proper curing should be done for up to 7-10 days. For F2-A-R2-W3/ F2-A-R6-W3 (Internal and External view), F2-B-R2-W3/F2-B-R7-W3 (Internal and External view) as shown in plate 8, these cracks are of the same pattern, which occurred at the internal and external view is a sign of total crack of the wall (See Table 3 and Plate 8), on a load bearing structure having mostly sandcrete block walls for supporting loads of roof beam and other roof loads, roof gutter, long-span aluminium roof covering, timber purlins, timber strut, timber wall plate, and wind load. Because of these loads, in course of time, RC columns undergo some shortening due to elastic deformation, creep and shrinkage and because of difference in the strains in RC columns and masonry; vertical shear crack appeared at junction of the two materials. The preferred solution for F2-A-R2-W3/ F2-A-R6-W4 (Internal and External view), F2-B-R2-W3/F2-B-R7-W3 (Internal and External view) is that, the cracked region could be repaired by first removing the cracked or affected portion of the block, and replaced with good quality, high strength block, properly cured and allowed to dry so as to undergo initial shrinkage and then bonded to the column with the use of correct mix ratio mortar 1 cement: 2 lime: 9 sand, and curing should follow to avoid shrinkage by thermal effect. Secondly, since the wall is built right up to the soffit of the roof beam, horizontal joint should be opened out, and filled up with some joints about 10mm in width formed at the top of the wall.

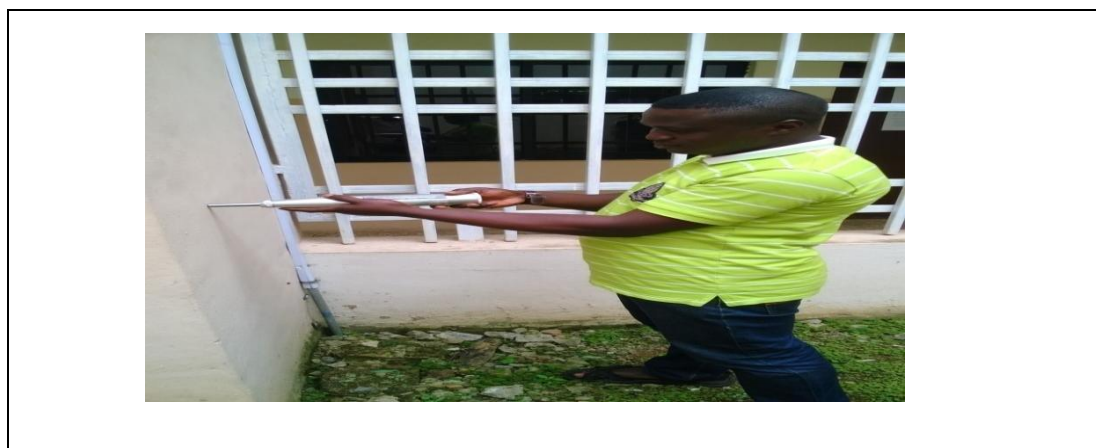
The summary of the results of the Rebound Hammer Readings conducted on the structural elements of the building under study are indicated in Table 4. The minimum compressive strength required in 28 days is $25N/mm^2$. The minimum compressive strength required in one year is $31N/mm^2$. The adequacy of a reinforced concrete structural element to support loads imposed on it, is determined by the compressive strength of concrete, dimension properties, reinforcement constituent and tensile strength of the reinforcement bars. For the buildings under investigation, Grade 25 concrete with 28day compressive strength of $25N/mm^2$ is considered appropriate and adequate. This is expected to attain $31N/mm^2$ in one year of the concrete age, and then marginally increase over the years. From the non-destructive Schmidt hammer rebound readings obtained for the structural elements, the average strength of the building varies between 36.8 and $48.2N/mm^2$ respectively, this is within acceptable limit, and it is therefore satisfactory.

Plate 9: Picture showing the schmidthammer reading of ground floor column
