Experimental investigations of hexagonal crimping die failure

ABSTRACT: This paper deals with the hexagonal crimping die failure of high carbon high chromium steel material. The failure modes were initially revealed and identified by the visual examination. Then the chemical analysis and metallographic examination have been carried at different positions of the failure die surface using scanning electron microscope (SEM). The microstructure evaluation reveals that failure occurs due to undissolved austenitic structure resulting in improper transition during heat treatment.

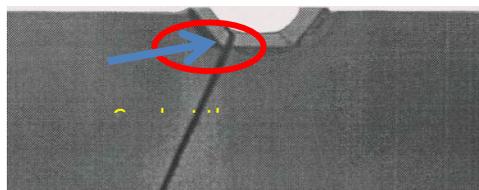
Fig. 4: Crack propagation on the hexagonal corner of die

The hexagonal crimping die failure mode, which is used to connect ball bin and ball tube were carried out initially by visual inspection of the failed die. The surface of the die reveals crack at the hexagonal corner and it is propagating inward at the bottom of the die as shown in Fig.4. This occurs due to contact pressure between the hexagonal crimping die and the ball bin and ball tube during operation [6]. This initial crack after continuous usage of the crimping die has progressed to the surface and the failure of the die into two pieces has taken place, which is shown in Fig.5.

Even though the combined stress developed in the die was within the allowable limit, the applied load was varying at each and every cycle tries to push the side surfaces due to ball tube expansion; this in turn leads to different stress concentration in the hexagonal corners and surfaces of the die. This continuous fluctuating stress at every cycle has led to the formation of fine cracks at the hexagonal corner and after some cycles of application has propagated inward into the die.

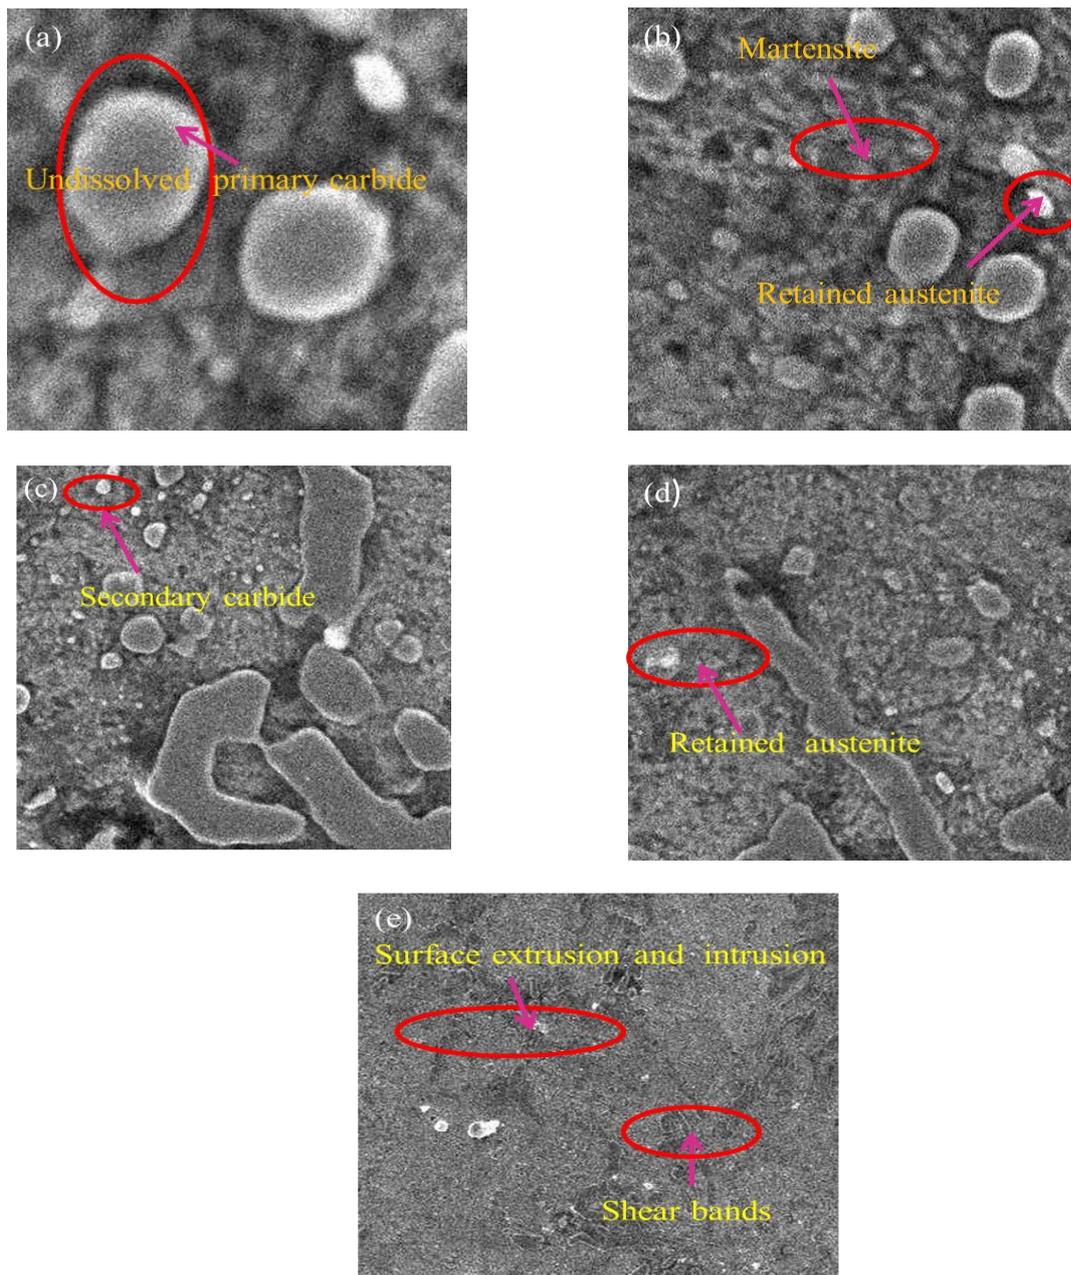
Fig. 6. characterization of phases and defects in AISI D3 die material.

- (a) Undissolved primary carbide
- (b) Martensite and retained austenite
- (c) Secondary carbide
- (d) Retained austenite
- (e) Shear bands

The microstructure of various portion of the specimen of D3 steel is shown in Figures.6(a) to Fig.6(e). Fig. 6(a) and 6(b) shows the microstructure composed of undissolved large primary carbide, tempered martensite and retained austenite [11]. Martensitic structure is always associated with the percentage of carbon of the parent austenite phase; it may form either low carbon or high carbon martensite phase. Low carbon martensitic phase exhibits high toughness, ductility but having low strength. Similarly, high carbon martensitic structure exhibits higher strength but having brittle and non-ductile [10, 11]. From table 3 it is observed the percentage of carbon in HcHcr is 2.28. From this it can be concluded, that the HcHcr exhibits higher strength and having brittle and non-ductile. Also, it is known that increase of carbon content of austenite leads to decrease in martensitic start temperature and martensitic finish temperature [11, 12]. This in turn leads to difficulty in converting austenite to martensite. The probably causes of this can be seen in Fig.6(a) with undissolved carbide in the martensitic structure. This undissolved carbide phase is not desired, caused earlier failure of the die within the allowable cycle.

The Fig.6(c) shows that primary and secondary carbides and also the carbides were very coarse and inhomogeneous [5, 10]. From Fig.6(e) it is observed a narrow zone of intense shear strain developed caused due to severe deformation (Shear band). Also, visible lines were observed on the surface that shows residue of the material extruded and has stuck to the die creating embossed lines (surface extrusion and intrusion). From this it is evident that sudden brittle failure has occurred without any material deformation. From this it is observed that improper cooling rate has caused undissolved carbides and retained austenite phase in the material. This undissolved carbide has led to increase in stress concentration and induced failure of the die.

This failure investigation revealed that the AISI D3 material chemical composition and hardness of the material were within the acceptable limit. The metallographic examination of the fracture surface by scanning electron microscopy shows that the fracture occurs due to undissolved primary carbide, coarse carbide present in the martensite structure resulting in reduction of material strength. The combined stress developed in the die was very nearer to the yield strength of the material, which leads to higher stress concentration on the hexagonal sharp corner due to cyclic load variation. This shows that the probable failure occurs due to fatigue. From this it can be concluded that the design changes in the sharp corner of die and proper heat treatment and slow cooling method improve the martensite structure of material. This gives greatest life cycles to the die.
