Characterization of Brick Made From Sewage Sludge of Water Treatment Installation 2 Pdam Bandarmasih as a Construction Material

ABSTRACT: The increasing price of light brick and clay brick quality, it is deemed necessary to make bricks using materials that are cheaper and easier to obtain, namely by utilizing sludge of Water Treatment Installation 2 PDAM Bandarmasih. For this reason, a study is needed to utilize the abundant sludge waste, while also aiming to reduce the negative effects caused by the accumulation of sludge.

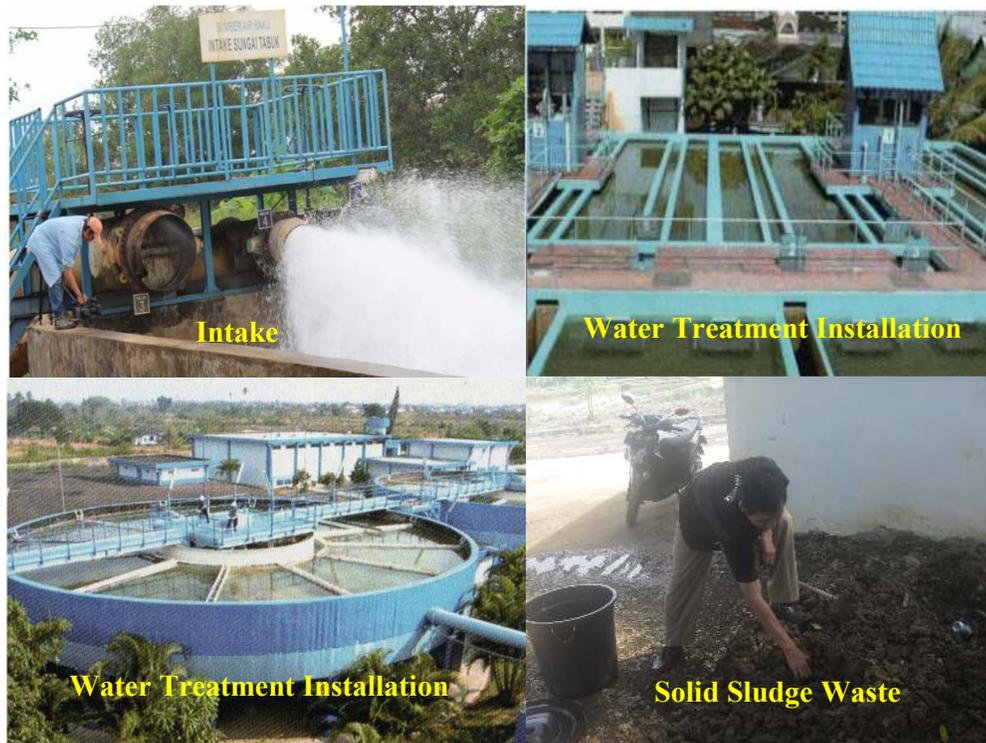
The material for making bricks is sludge from raw water that has been compacted at the Water Treatment Installation 2 PDAM Bandarmasih is located on Pramuka Street Complex Tirta Dharma Km. 6 Banjarmasin City, South Kalimantan Province, Indonesia and PDAM water used in the process of dozing the material so that the texture becomes homogeneous. The Water Treatment Installation 2 PDAM Bandarmasih and solid sludge waste as shown in Figure 1.

Figure 1. Water Treatment Installation 2 PDAM Bandarmasih and Solid Sludge Waste

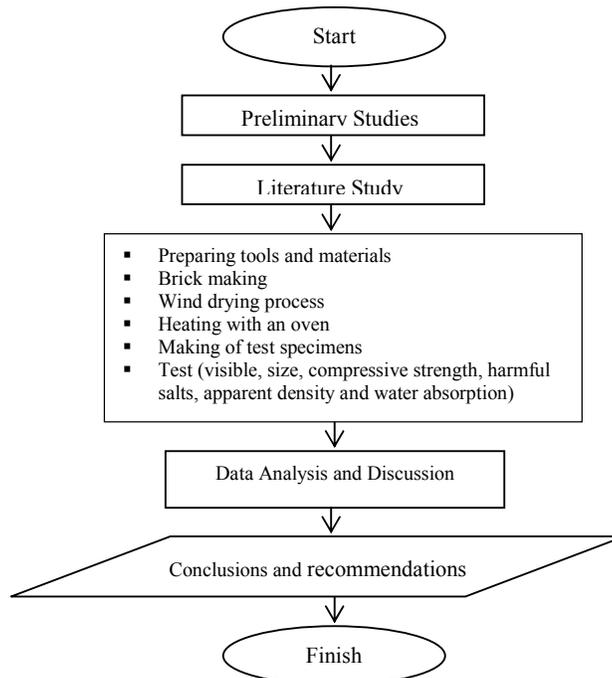
The stages in this study can be described in the form of a flowchart as Figure 2.

Figure 2. Research Flow Chart

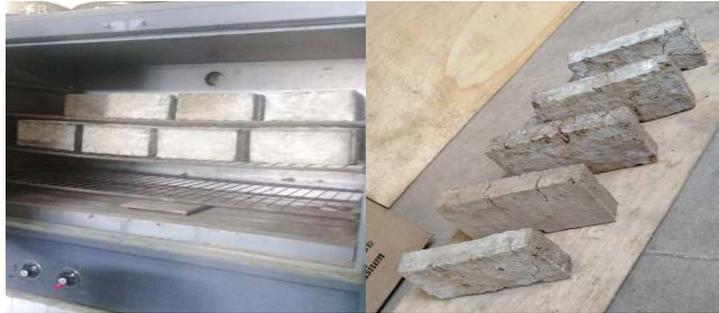
Based on the visible properties test results of the bricks in oven-dry condition as listed in Table 3, it was found that of the 10 bricks tested none of them met the flat-shape, elbow-shape and has no cracks as required in SNI 15-2094-2000. Although out of the 10 bricks there are 7 pieces (70%) bricks that have a flat-shape and all bricks (100%) have an elbow-shape, all bricks are considered not to meet the SNI 15-2094-2000 standards because all bricks have cracks which cracks included in the weight category. The bricks visibility test in oven-dry condition as shown in Figure 3.

Figure 3. The Brick Visibility Test in Oven-Dry Condition

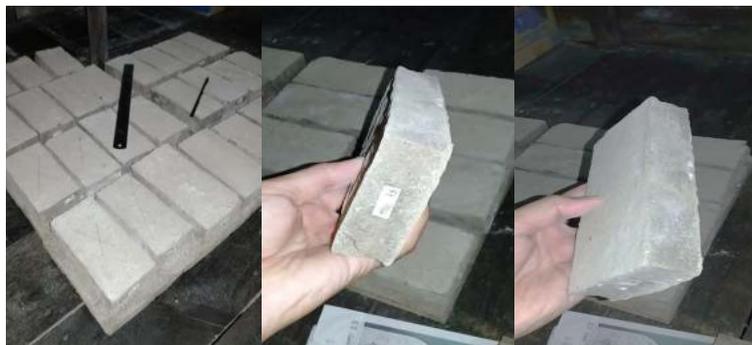
Based on the visible properties test results of the bricks in wind-dry condition as listed in Table 4, it was found that of the 10 bricks tested there were 5 (50%) bricks that met the flat-shape, elbow-shape and has no cracks as required in SNI 15-2094-2000. Out of these 10 bricks, there are 7 bricks (70%) that have a flat-shape, 3 bricks (30%) with curved-shape, 10 bricks (100%) have elbow-shape, 5 (50%) light cracked bricks and 5 (50%) bricks with no cracks at all. The brick visibility test in wind-dry condition as shown in Figure 4.

Figure 4. The Bricks Visibility Test in Wind-Dry Condition

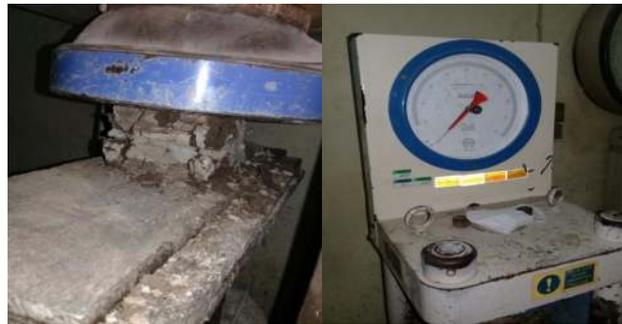
Based on the compressive strength test results obtained the average compressive strength value of 17.79 kg/cm², as listed in Table 7. The average compressive strength value of bricks does not meet the SNI 15-2094-2000 standard, where the minimum compressive strength value of 30 bricks tested for the lowest class, which the lowest compressive strength of class 50 is 50 kg/cm². The bricks compressive strength test as shown in Figure 5.

**Figure 5.** The Bricks Compressive Strength Test**Table 7.** The Bricks Compressive Strength Test Results

The compressive strength value of the bricks is very low because sludge of Water Treatment Installation 2 PDAM Bandarmasih which is used as material for making the bricks has fine-grained characteristic, loose and high water absorption. Excessive water content in the bricks structures can reduce the bonding capacity between soil particles, thereby reducing the compressive strength of the bricks.

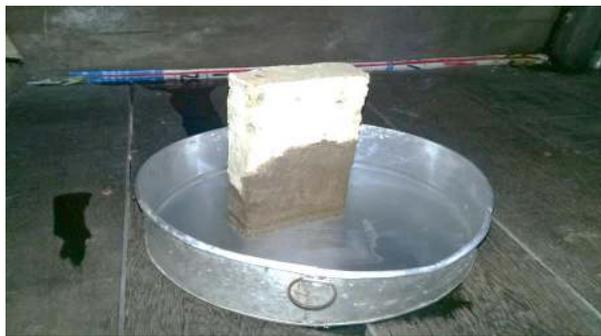
The bricks used in the harmful-salt test are bricks that are dried by the wind. This test is done by checking how much salt crystals cover on the brick surface. Based on test results of 5 bricks obtained 100% of bricks have a salt crystal surface area of less than 50% of the total surface area of the bricks, so according to NI-10, 1978 these bricks are categorized as not harm. The harmful salt test results can be seen in Table 8. Soaking bricks for salt crystal observation can be seen in Figure 6.

Figure 6. Soaking Bricks for Salt Crystals Observation

The Sludge of Water Treatment Installation 2 PDAM Bandarmasih as the material for making bricks is formed from weathering feldspatic rocks that move very large distances from the main rock. On the way due to water and wind, this soil is mixed with organic and an organic materials, thus changing the chemical and physical properties of clay into particles that produce finer and more plastic clay. In the process of forming this soil type is not dominated by elements that contain high levels of salt.

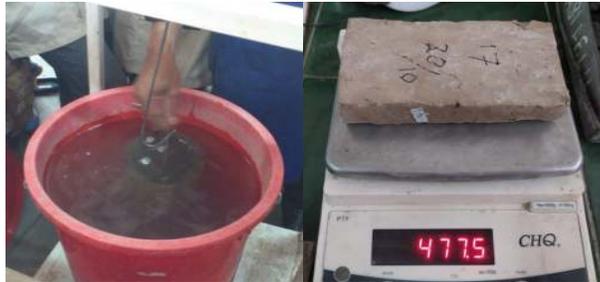
Based on the apparent density test results was obtained the average of apparent density value is 1.33 g/cm³. The apparent density value of bricks meets SNI 15-2094-2000 because it is higher than the minimum apparent density value required in SNI 15-2094-2000, which is 1.2 g/cm³. The apparent density test results of 10 bricks can be seen in Table 9. The brick apparent density test as shown in Figure 7.

Figure 7. The Brick Apparent Density Test

The average of apparent density value of bricks meets the minimum apparent density value standard required in SNI 15-2094-2000. The soil from sludge of Water Treatment Installation 2 PDAM Bandarmasih as brick making material has fine grained characteristic and high shrinkage, so when it is perfectly dry, this soil will solidify optimally and be resulting a high apparent density material.

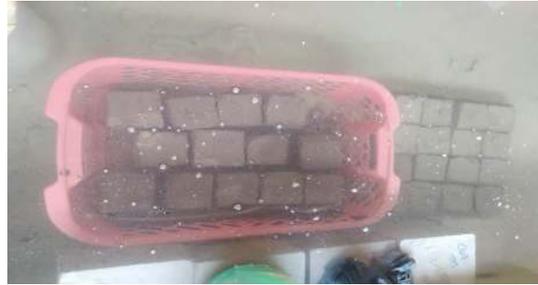
Based on the water absorption test results was obtained the average value of water absorption is 22.01%. The value of water absorption of bricks does not meet the requirements of SNI 15-2094-2000 because the value of water absorption is higher than the maximum water absorption required in SNI 15-2094-2000, which is 20%. The water absorption test results of 10 bricks can be seen in Table 10. The bricks water absorption test as shown in Figure 8.

Figure 8. The Bricks Water Absorption Test

The average water absorption value of bricks does not meet the maximum water absorption standard required in SNI 15-2094-2000, because the soil from sludge of Water Treatment Installation 2 PDAM Bandarmasih as material for making bricks has high water absorption characteristic, so that even when condition are dry the ability of soil water absorption is not lost.
