## Redesign and Construction of Corrosion Cell for Improved Measurement of Corrosion Under Insulation (CUI)

Gabriel ESSIEN<sup>1</sup> and Anne NEVILLE<sup>2</sup>

<sup>1</sup>Facilities Maintenance, Nigerian Petroleum Development Company Limited

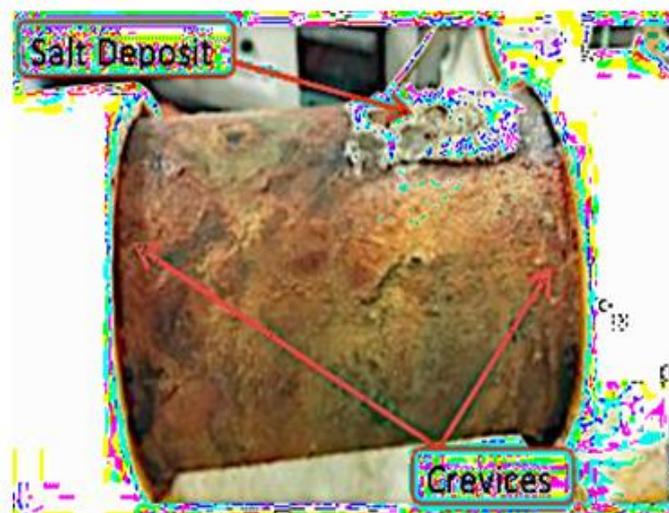
**Figure 9:** Schematic showing CUI on sample after testing

Figure 9 shows the presence of uniform and localized corrosion at the top positions of the test sample. Thick and dark rust stains were observed at crevices created at the sides of sample by insulation and joints between the Teflon spacer and test sample.

Salt deposits were observed at the top part where solution was introduced to wet the insulation. These salt deposits are formed by concentration cells due to solution evaporation or drying at the top portion of the test sample. The considerable formation of iron oxide confirms the reduction in corrosion rates due to these oxide layers. However, experiment to determine the constituent of this protective oxide film was not conducted. The evidence of localized corrosion such as pitting was observed on the test sample after cleaning the corroded surface with Clarke's solution (Figure 10).

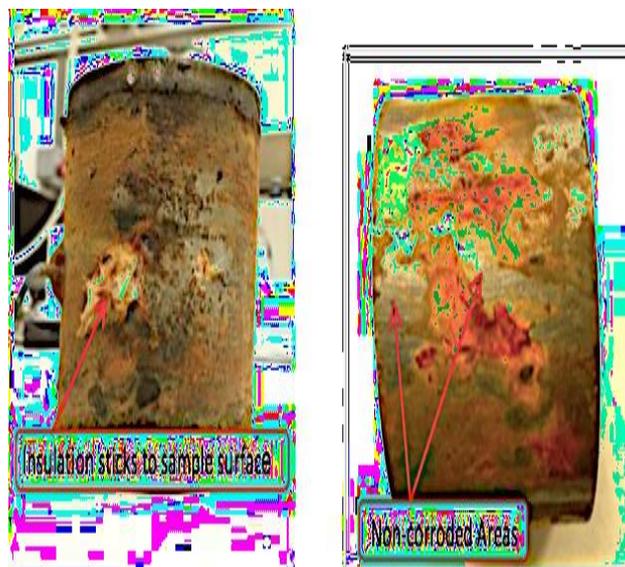
The other observations include the sticking of mineral wool insulation to test sample and also the presence of non-corroded areas on the sample surface (Figure 11).

**Figure 11:** Schematic showing stuck insulation on test sample with non-corroded areas.

The non-corroded areas of sample surface further confirm the presence of localized cells in CUI. Another likely promoter of these localized cells aside the ones mentioned in Section 3.3-3.4 is the hydrophobic property of mineral wool insulation.

The hydrophobic chemical additives are added by manufacturers to repel water absorption in insulation. However, eventually when there is water ingress, this property tends to break and separate water into large droplets that will enhance formation of localized cells as can be seen in Figure 11 above. No experiment was conducted to confirm this activity.
